Northeast Aquatic Research

Lake Waramaug 2021 Invasive Species Report

Prepared for the Lake Waramaug Task Force

February 2021

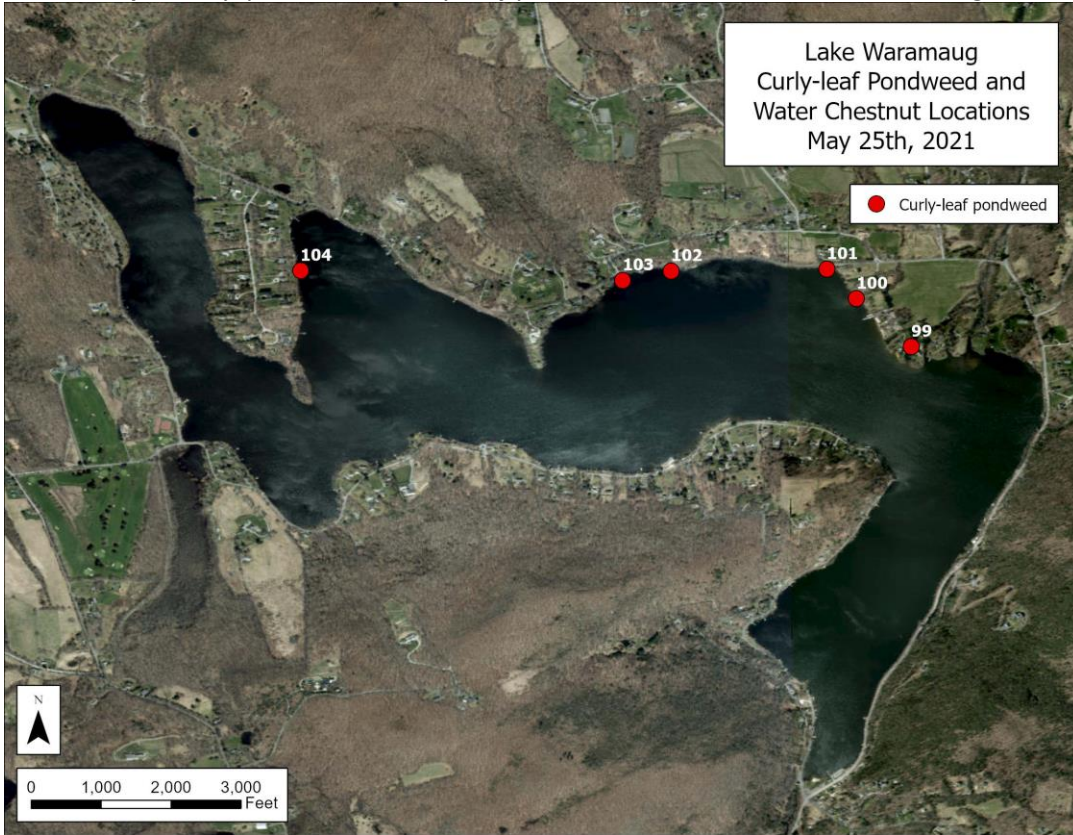
Map 1. May/pre-removal curly-leaf pondweed locations in Lake Waramaug.

During the May pre-removal survey, curly-leaf pondweed plants were found in only six locations along the lake's northern shoreline. No plants were found in the western State Park arm, or along the southern shore (**Map 1**). Four of the six locations were isolated plants. The two eastern-most locations contained the largest patches. Waypoint #99 contained approximately 20 plants, and the 10 plants at waypoint #100 (Sachem Brook) were large and bushy and grew to the surface (**Table 1**).

Waypoint number and description	# of Plants
99 - patch of large plants at inner end of lagoon	20
100 - clump of large plants inside mouth of Sachem Brook	10
101 - isolated plants on lake shore	5
102 - isolated plant on lake shore	1
103 - isolated plant on delta of brook	1
104 - isolated plants on lake shore	2

Continued annual pre-removal surveys are necessary for locating all curly-leaf plants, along with searching for any other invasive species and removing them immediately, when possible. These surveys are timed to be conducted as soon as curly-leaf pondweed begins to grow, typically around May 25th. surveys conducted earlier are unsuccessful at finding the plants, while waiting too much later risks allowing plants to mature and begin forming turions.
