**Northeast Aquatic Research**

# **Lake Waramaug 2019 Treatment Report**

**Prepared for the Lake Waramaug Task Force**

**December 2019**

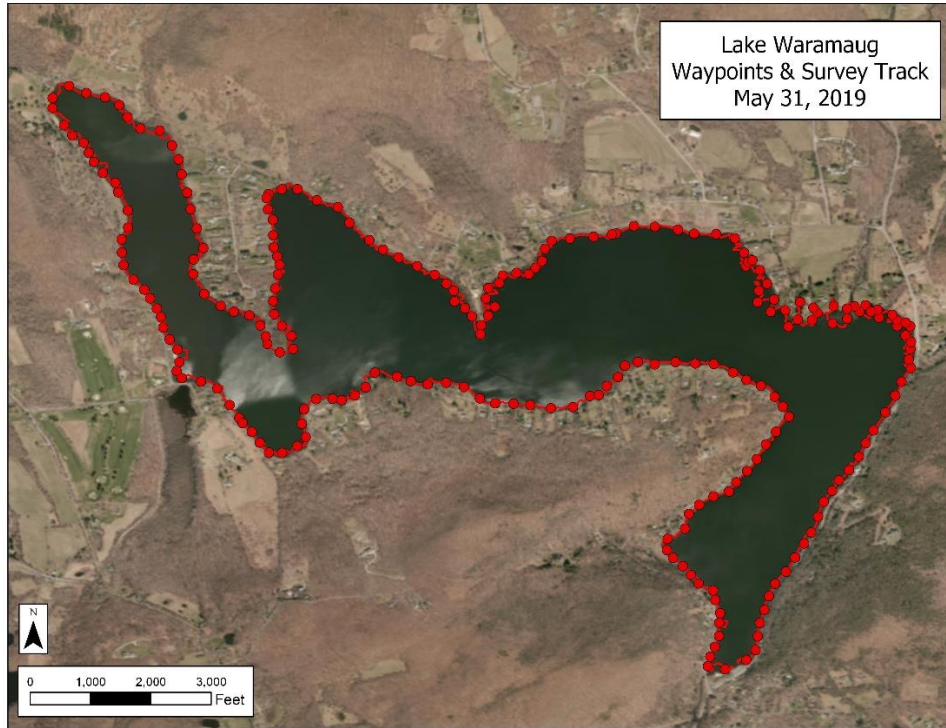
**Map 1.** May 2019 survey waypoints and track.

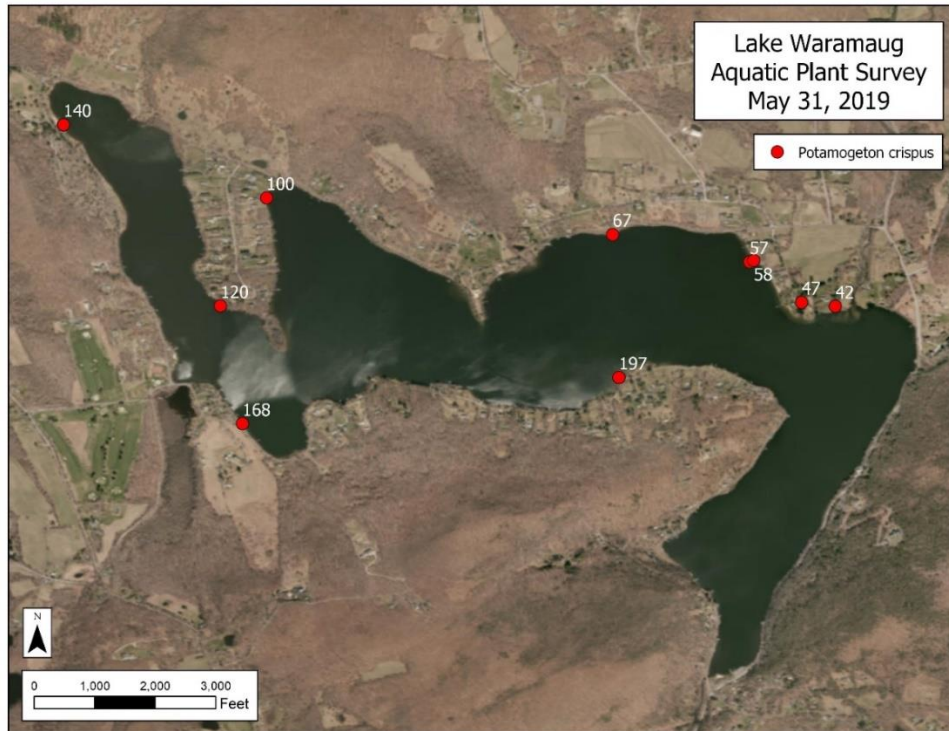
During the May pre-treatment survey, curly-leaf pondweed was present at 10 waypoints (**Map 2, Table 1**). The highest concentration of curly-leaf beds was in the northeastern portion of the lake, in Sucker Brook Cove, with a handful of other beds scattered around the shoreline of the lake. There was noticeably less curly-leaf in 2019 compared to recent years' pre-treatment surveys (see historical curly-leaf pondweed maps in appendix). In 2018, and previous years, curly-leaf has consistently been found in the north-eastern bay and along the eastern shoreline of the lake. In 2019, no curly-leaf was found in this bay.

**Map 2.** May/Pre-treatment 2019 *Potamogeton crispus* locations in Lake Waramaug.

The results of the 2019 pre- and post-treatment surveys suggest that the yearly suction-harvesting efforts are beginning to effectively reduce the amount of curly-leaf pondweed in Lake Waramaug. Curly-leaf plants release turions (winter buds) that form a dense seed bank over the years and can support new plant growth in future years. The annual removal of curly-leaf plants from the lake is diminishing this seed bank.

Although no curly-leaf plants were found in the lake during the 2019 post-treatment survey, it is likely that new plants will sprout from the seed bank in the spring of 2020. Ultimately, continued annual surveying and removal efforts can lead to complete eradication of curly-leaf pondweed from Lake Waramaug.

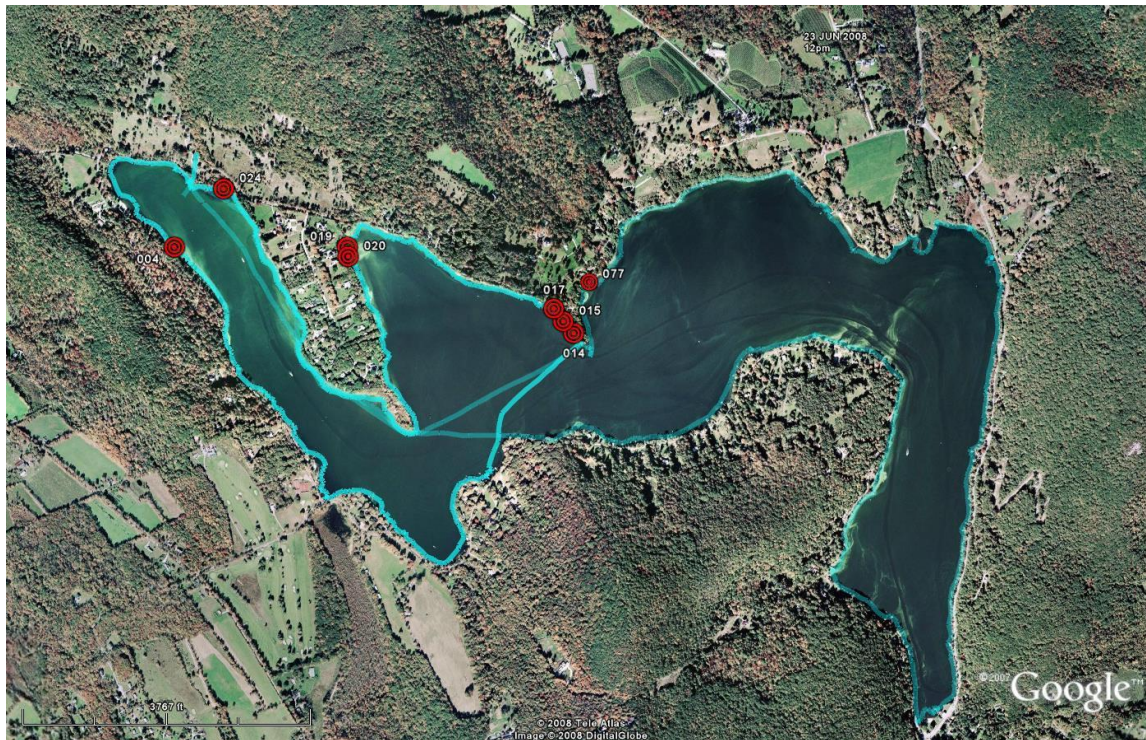
**Map 10.** Lake Waramaug showing sites where curly-leaf pondweed was observed during June 18, and July 2, 2008 surveys.
